National Center for Research on  
Earthquake Engineering

# Testing Report

Report Number : NCREE-LT-TQM-D-T1601

Test Name: **Optimus Type Busway**

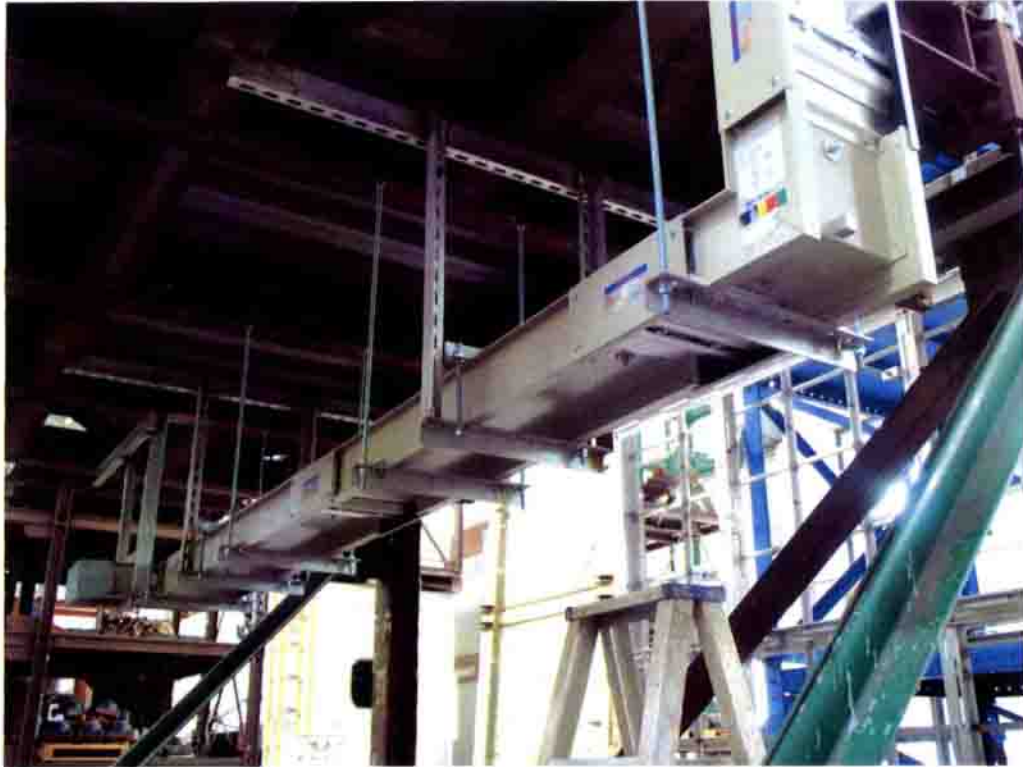
Figure 4: Close-up view of the busway system.

4. The three-story steel frame was bolt-mounted onto the shaking table platform. Figure 3 shows the photographical view of the three-story steel frame with busway system mounted. Figures 4-6 show close-up photographical views on the important parts of the busway system.

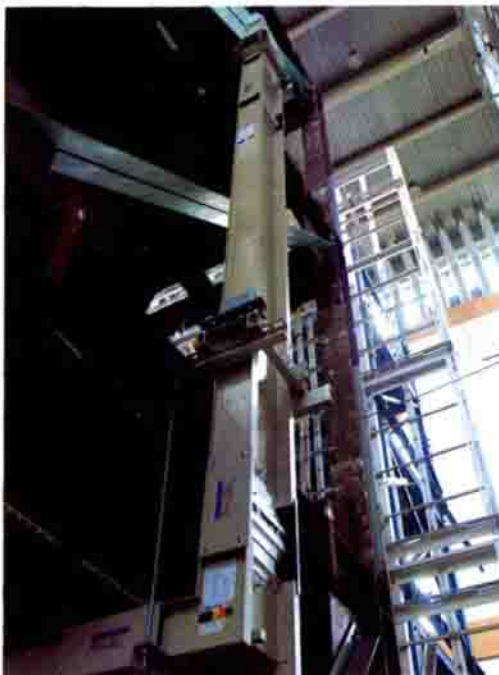
Figure 5: Close-up view of the busway system. Figure 6: Close-up view of the busway system.
